Hydrogen Fuel Tank Fire Exposure Burst Test

ABSTRACT

A fire exposure test was conducted on a 72.4 liter composite (Type HGV-4) hydrogen fuel tank at an initial hydrogen pressure of 34.3 MPa (ca 5000 psi). No Pressure Relief Device was installed on the tank to ensure catastrophic failure for analysis. The cylinder ruptured at 35.7 MPa after a 370 kW fire exposure for 6 min 27 seconds. Blast wave pressures measured along a line perpendicular to the cylinder axis were 18% to 25% less the values calculated from ideal blast wave correlations using a blast energy of 13.4 MJ, which is based on the ideal gas internal energy at the 35.7 MPa burst pressure. The resulting hydrogen fireball maximum diameter of 7.7 m is about 19% less than the value predicted from existing correlations using the 1.64 kg hydrogen mass in the tank.

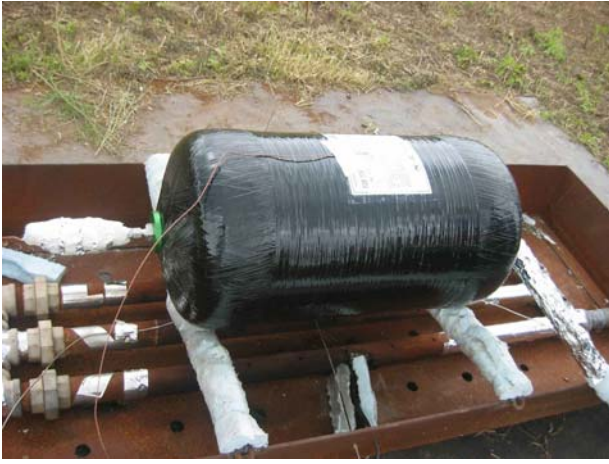
The 72.4 liter (4420 in³) capacity 5000-psig (34.5-MPa) cylindrical tank had a high-density polyethylene inner liner, a carbon fiber structural layer, and a protective fiberglass outer layer. The cylinder's outside dimensions were approximately 0.84 m (33-in.) long with a 0.41 m (16-in.) diameter. Its ends were domes equipped with SAE threaded fittings for filling, and pressure measurement, and normally for a PRD. No PRD was used in this test.

Figure 1. Hydrogen Tank Prior to Test

The cylinder was placed with its axis oriented horizontally over the bonfire (Figure 1). A propane fire exposure was set up using the wind-barrier pan and perforated piping shown under the tank in Figure 1. Propane flowed out of the perforations directly below the 0.84 m (33 inch) long tank.

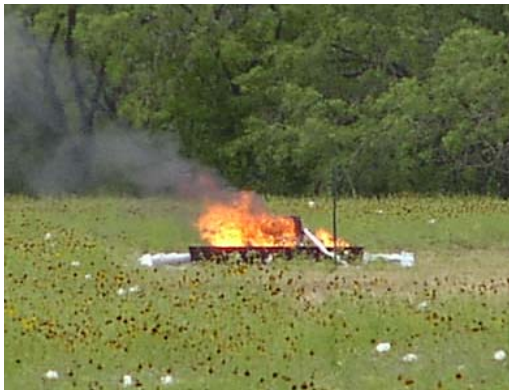
Propane flow began at approximately 415 scfh, and was quickly increased to approximately 580 scfh for the duration of the test. This corresponds to a heat release rate of approximately 370 kW (21,000 Btu/min), assuming a 95% burning efficiency. The resultant propane fire engulfed the tank, but was somewhat asymmetrical in the 3.6 m/s (8 mph) wind, as shown in Figure 2.

Figure 2 Exposure Fire Engulfing Tank

Fiberglass on the outer surface of the tank began burning approximately 45 sec into the test. The internal cylinder temperature and pressure slowly increased during the exposure.

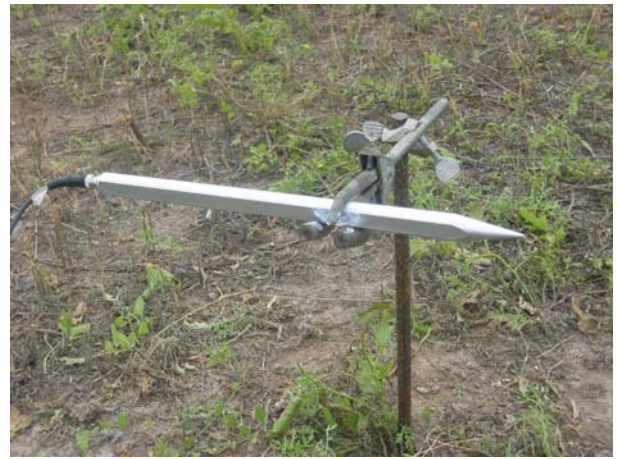
Blast-wave pressures were measured with four piezoelectric blast-wave pressure probes mounted on a steel rod at the elevation of the cylinder's axis (Figure 3). Three probes were located perpendicular to the axis of the cylinder, at distances of 1.9 m (76 in.), 4.2 m (166 in.) and 6.5 m (256 in.) from the center of the tank. The remaining probe was located just off the axis of the cylinder; approximately 4.2 m (166 in.) from the center of the cylinder, placing it equidistant as the second pressure probe perpendicular to the cylinder.

Figure 3. Blast wave transducer

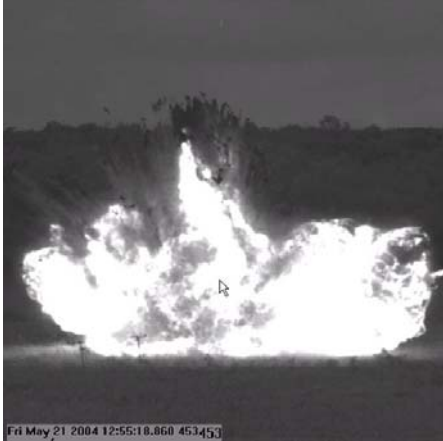
Figure 5a-d is a sequence of four images of the fireball formed upon cylinder rupture. It starts as a rapidly expanding flame, with a height/diameter ratio of about 1/3 in the first image. It reaches its maximum diameter of about 7.7 m (25 ft) in the second image. The flame has a more spherical shape in the third image, and has lifted

Figure 5a Fireball 10 msec after rupture.

One striking feature of the first three fireball images is the sharply varying luminosity of the flame. Presumably the inhomogeneous flame is caused by different fuels burning. Besides the hydrogen, there are polyethylene decomposition products and fragments of carbon fibers. The IR camera images also revealed large variations in flame temperature, with the highest temperatures occurring near the periphery.

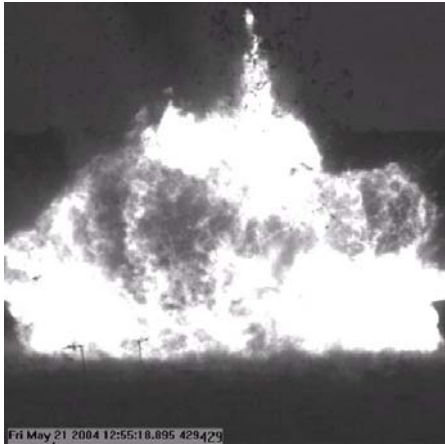
Figure 5b Fireball 45 msec after rupture.

where D_f is in meters, and W_f is the weight of hydrogen fuel in kilograms. With a weight of 1.64 kg (3.62 lb_m), the calculated fireball diameter is 9.36 m (31 ft). Thus, the observed fireball maximum diameter of 7.7 m (25 ft) is approximately 19% less than the value predicted from Eqn 4. The precise observed diameter varies only slightly among the images recorded by the various cameras, but the limited spectral range of the IR camera may have prevented observation of gaseous combustion products radiating in the UV and short wave IR portions of the spectrum.

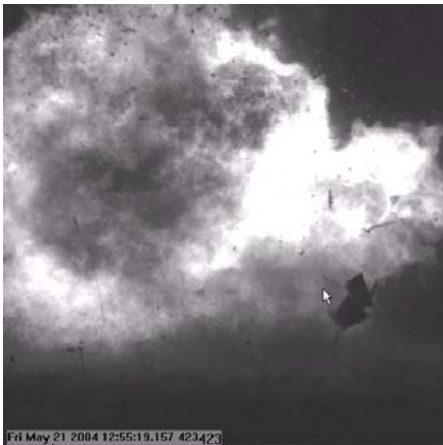
Figure 5c Fireball 107 msec after rupture.

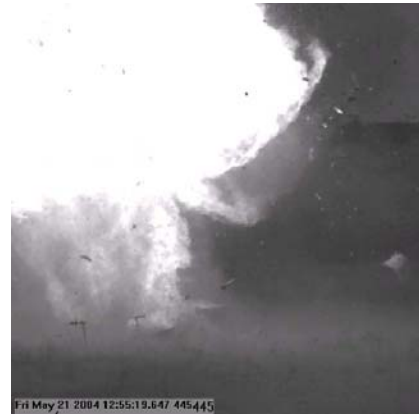
off the ground in the fourth image about 1 second after cylinder rupture.

Figure 5d Fireball 997 msec after rupture.

Equation 5 predicts a fireball duration of approximately 0.6 seconds. The observed fireball duration was about 2 seconds from the high-speed camera and about 4.5 seconds on the IR camera record. More recent fireball duration correlations described in References 4 and 6 suggest that Equation 5 is only applicable to momentum-dominated fireballs, whereas buoyancy dominated fireball durations are better correlated by:

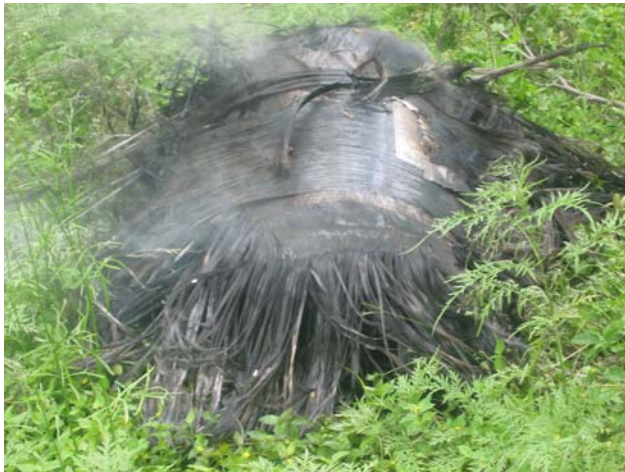
The largest projectile formed upon cylinder rupture was found smoldering 82 m (270 ft) east of the original test location (Figure 6). The projectile weighed 14 kg (31 lb_m), approximately 43% of the original cylinder weight.

Figure 6 Top half of tank with residual fire

The total weight of the four main recovered projectiles was about 61% of the original cylinder weight of 32.0 kg (70.6 lb). Another 2.1 kg (4.6 lb) of small debris

(polyethylene pieces and carbon fibers) was also recovered. The remaining 32% of the original mass presumably burned during the exposure fire or was dispersed as very small projectiles (including soot) and unburned carbon fibers.

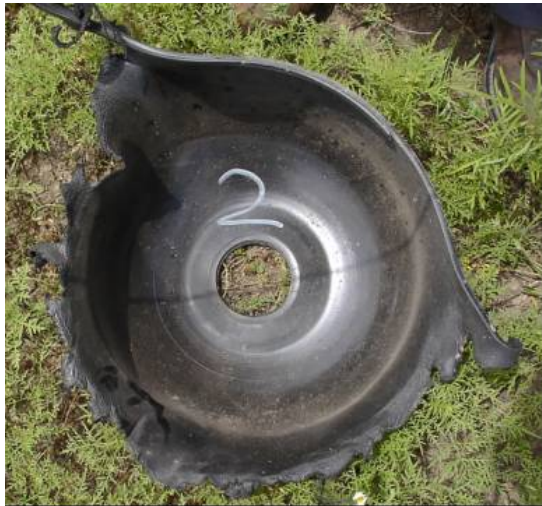
The two plastic cylinder dome liners, weighing 2.0 kg (4.3 lb) each, were found approximately 49 m (160 ft)

Figure 7 Cylinder dome end cap projectile.

northeast of the original cylinder location. One of the domes is shown in Figure 7. A 1.6 kg (3.6 lb) cylindrical piece of liner was found 33.6 m (74 ft) from the test site.
